**POLARIS****TECHNICAL SERVICE BULLETIN**

Bulletin Number: A-17-01-E

***** BULLETIN A-17-01-E Supersedes ATV-15-02/A *******SUBJECT:****2015 Sportsman 1000 1-Up Thermal Protection and Silencer Spring / Seal Update****PURPOSE:**

APPLICATION: 2015 SPORTSMAN 1000 1-UP

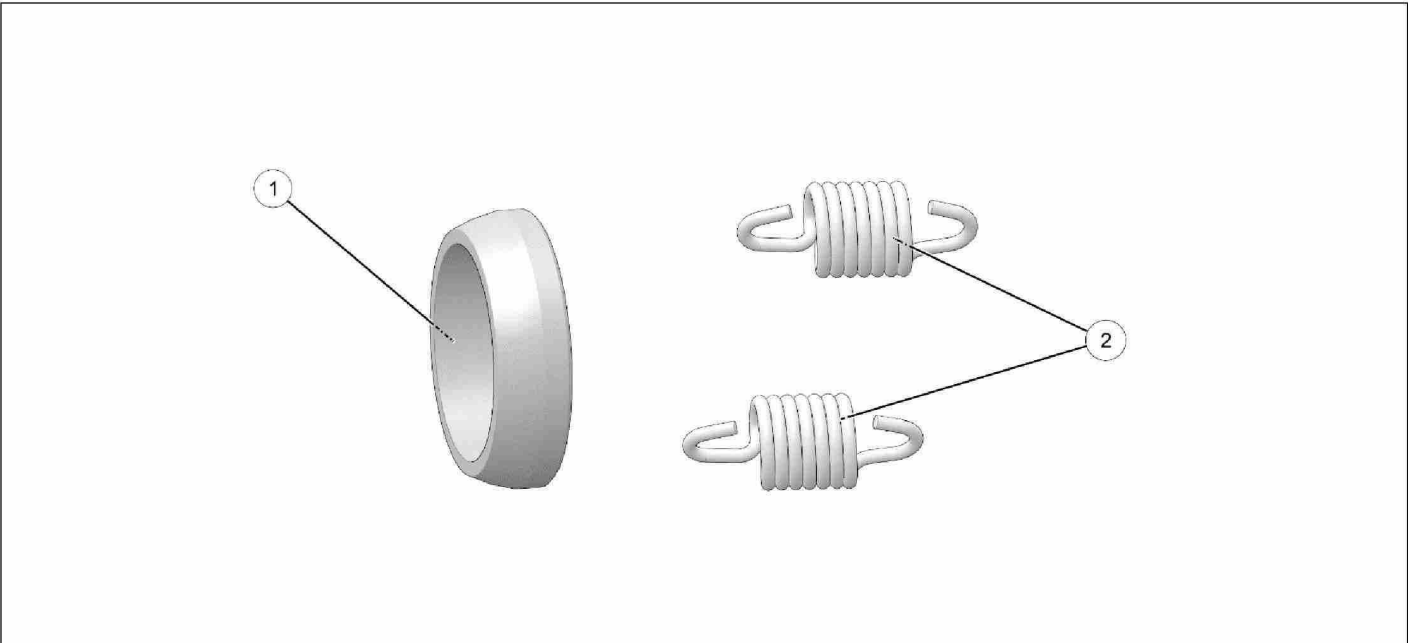
A-17-01-E KIT CONTENTS (P/N 2206202):

REF	PART DESCRIPTION	PART NUMBER	QTY
①	Exhaust Seal	3610204	1
②	Stainless Steel Exhaust Spring	7044452	2

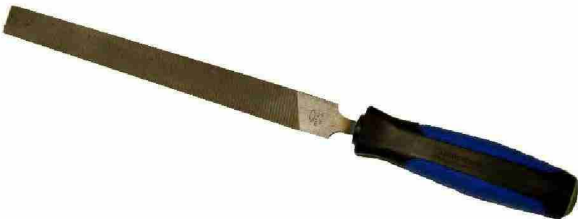
- Multi-function Pliers (Tuflok removal tool)
 - T-27 Torx Driver
 - T-40 Torx Driver
 - 10 mm Combination Wrench
 - 6 mm, 17 mm, 10 mm, and 11 mm Sockets
 - Scissors or Utility Knife
 - Suitable Flat Bladed Tool
 - Paper
- Paint Pen (White or Yellow)
 - DREMEL® with a two flute bit intended for plastics, a Reciprocating Saw or Similar Device (shown below)
 - Torque Wrenches (one for in/lbs, one for ft/lbs)
 - Driver for sockets (Breaker Bar, Ratchet, or equivalent)
 - Spring Puller
 - Rivet Gun
 - Water
 - Sponge or Cloth
 - Lint Free Cloth
 - Dish Soap
 - Half Round File (shown below)

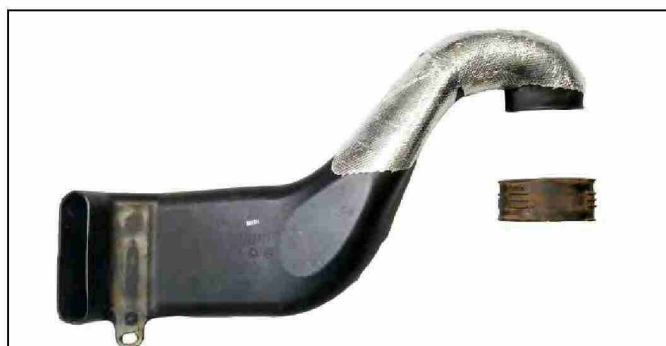
14. Remove the clutch outlet duct ⑮.

15. Discard the outlet duct boot, clutch duct, and the fiber foil attached to the outlet duct.

Retain worm clamps for installation of new duct.

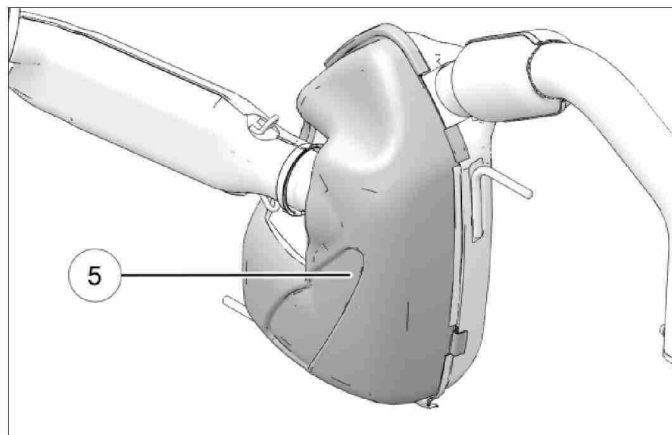
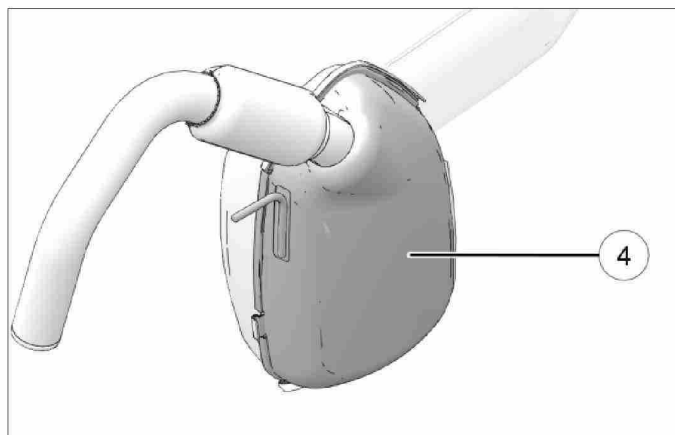
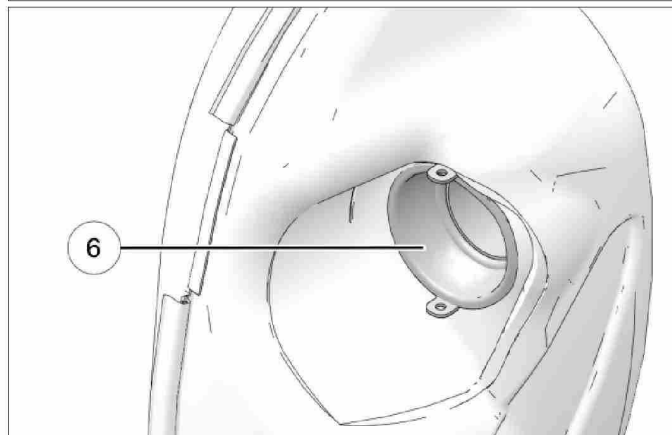
If the silencer assembly inner baffles are loose, heat absorption material ⑤ (between the outer heat shields and inner silencer) is missing or damaged, or the exhaust silencer socket ⑥ weld is broken or socket is distorted where the NEW exhaust seal seats, file an ASK Polaris case for replacement silencer assembly (P/N 1262570).

- A. Inspect the silencer assembly by shaking / lightly bouncing silencer assembly on work bench to determine if inner baffles are loose. Replace the silencer assembly if inner baffles are loose.
- B. Inspect outer clamshell heat shield ④. Replace the silencer assembly if any crimps around the perimeter of the heat shields are separated.
- C. Inspect inner heat absorption material ⑤ between the outer heat shields and inner silencer. Replace the silencer assembly if material is burned / missing, etc.
- D. Inspect exhaust silencer socket ⑥. Replace the silencer assembly if weld is broken or socket is distorted where the NEW exhaust seal seats.

A secondary dealer representative must verify the crimps around the perimeter of the outer clamshell heat shields ④ are secure and in good condition.

A secondary dealer representative must verify the inner heat absorption material ⑤ between the outer heat shields and inner silencer is properly secured and in good condition.

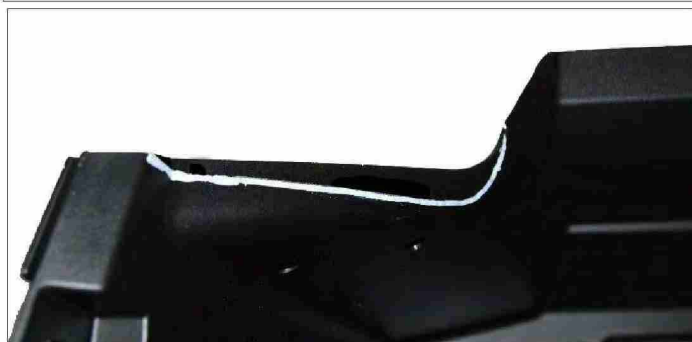
4. Trim the footwell using a DREMEL® with a two flute bit intended for plastics, a reciprocating saw or similar device leaving some material between the trim line and the paint pen line.

Do not trim up to the line with one cut. Cut the majority of the material then file up to the line, but leave the line.

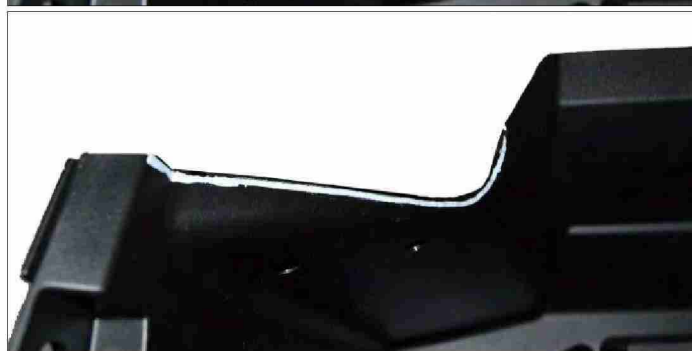
5. Using a DREMEL® with a two flute bit intended for plastics, a reciprocating saw or similar device, trim the footwell corner in line with the template (area circled in red shown in the **Before** and **After** images below).

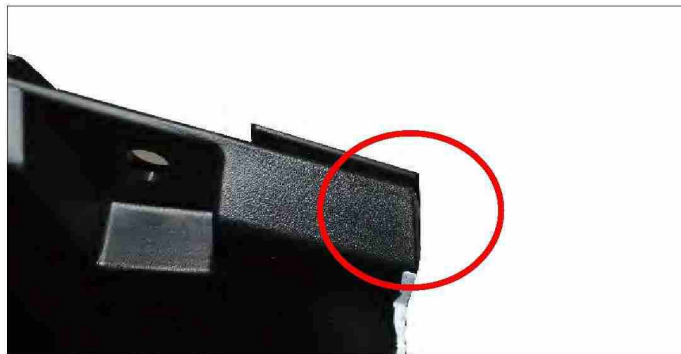
After

- Test fit the new panel to verify the footwell area trimmed does not contact the exhaust manifold side panel when the lower mounting surface is contacting the footwell.
- Align the mounting holes.
- Press the exhaust manifold side panel against the footwell applying pressure at or near the holes.
- Slide a piece of paper along the gap between the two panels.
 - If the paper slows or stops or the metal shield makes contact with the footwell, use a half-round file to trim the footwell to create a clearance gap between the components.
 - If the paper freely travels the length of the gap, and the metal shield does not contact the footwell, proceed to the audit and following steps.

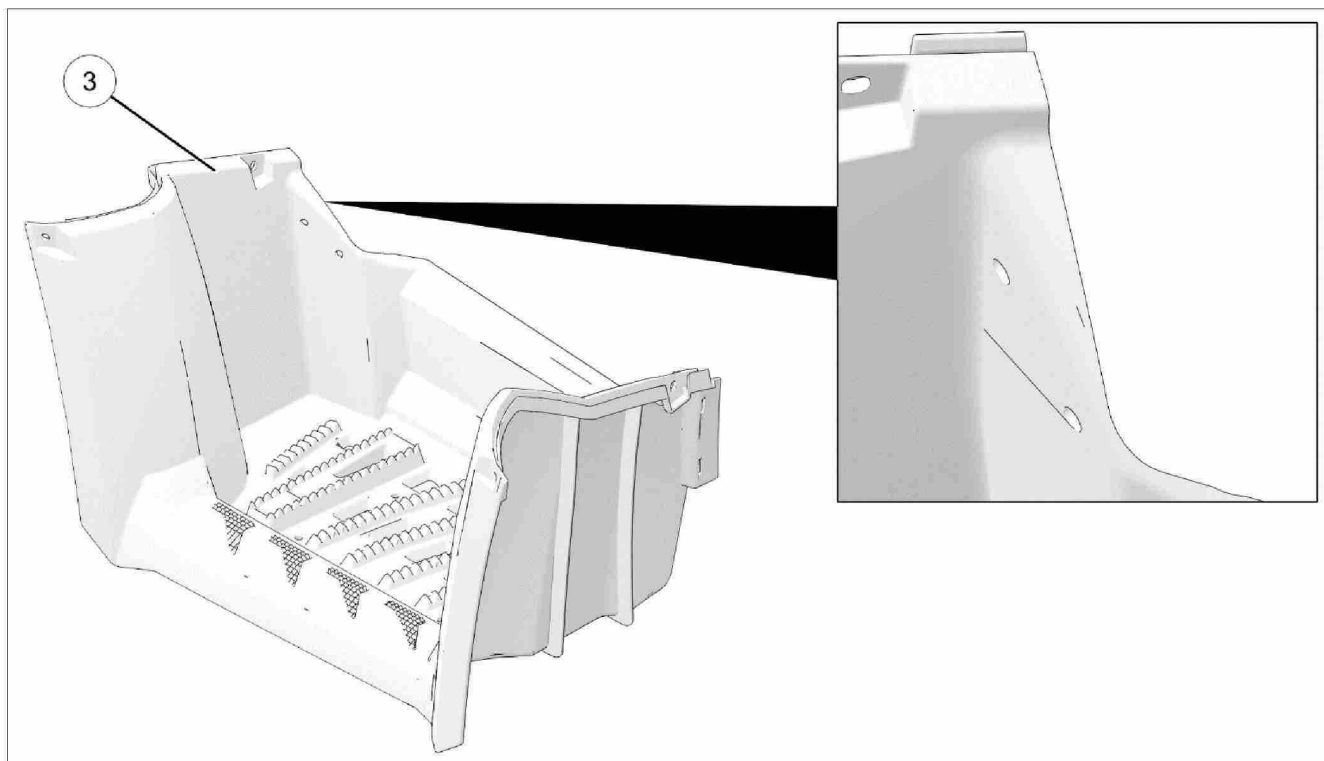
6. Using a half-round file, file and deburr the trimmed footwell ③. Ensure the footwell is clean, free of burrs, and maintains rider appeal. Verify trimmed area appears as shown in the illustration below.

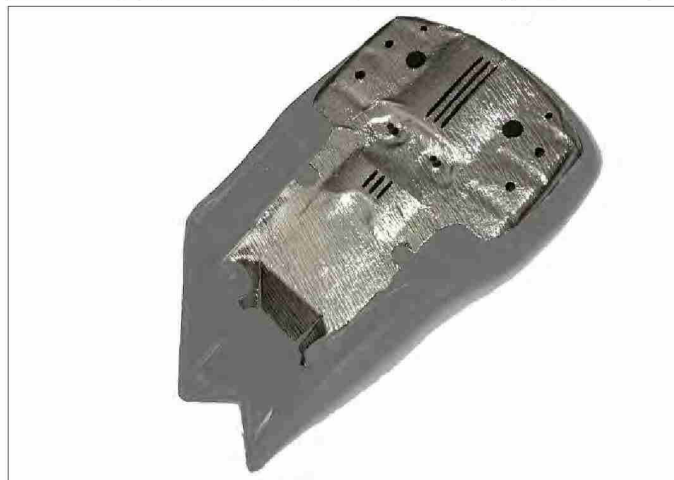
4. Thoroughly clean the area under where the new rear cab heat shield foil ⑥ will be applied with warm soapy water and a sponge. Dry the rear cab with a lint free cloth.

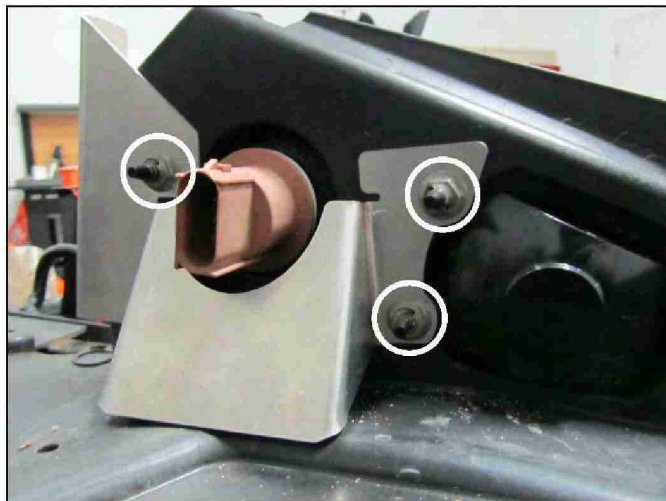
11. Align the new rear cab heat shield (5263209) ⑧ with mounting holes, and install the nylon plastic dart clips.

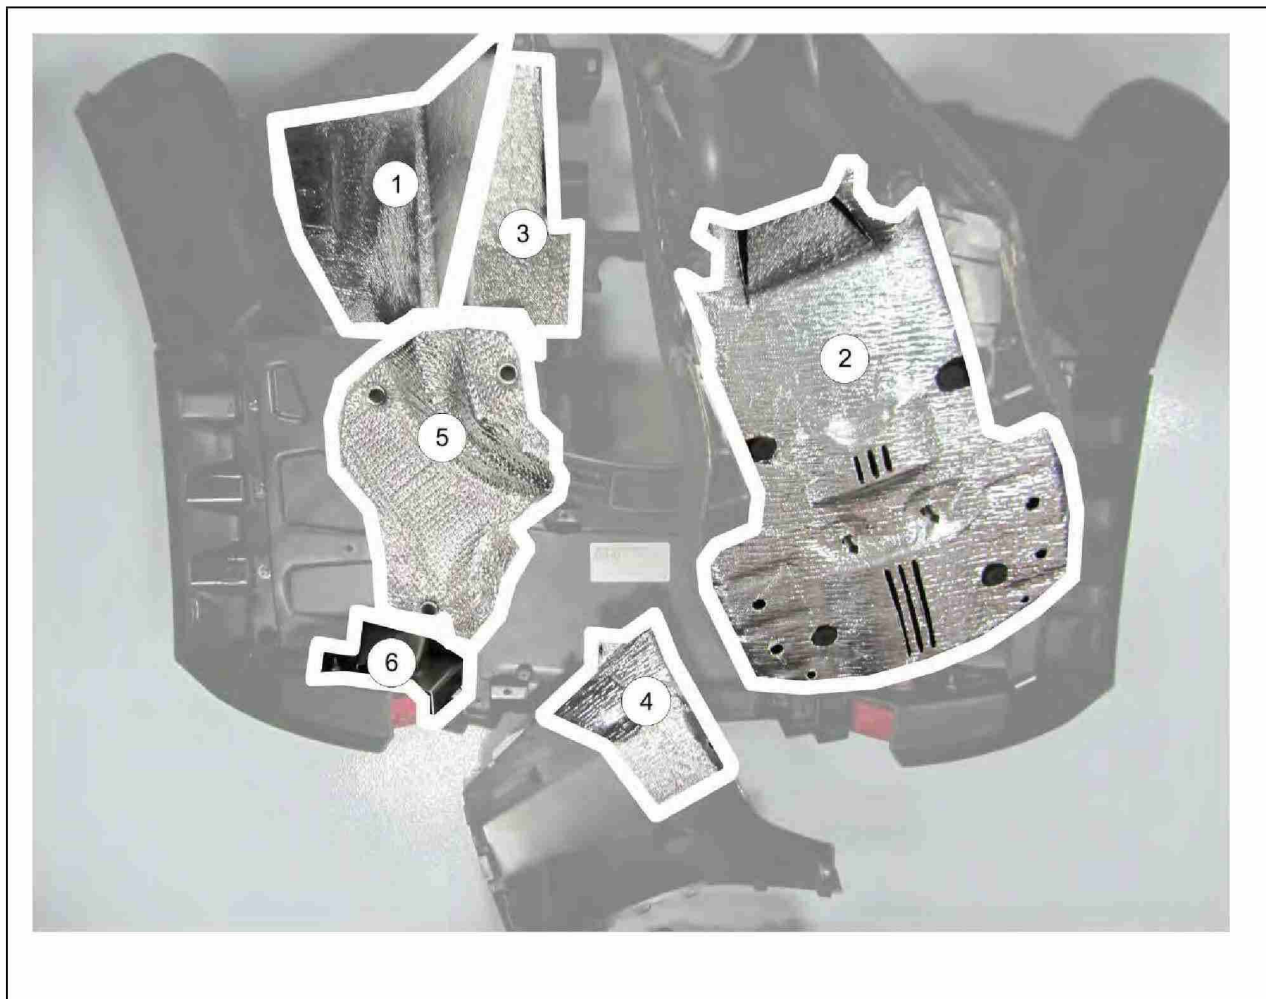
12. Take a picture of the cab, side panel, and seat so that all heat shields/foils on these components are visible. This is one of two pictures required to submit the warranty claim.

A secondary dealer representative must verify that all heat shield foils listed have been installed properly, and that the picture demonstrating this was taken.

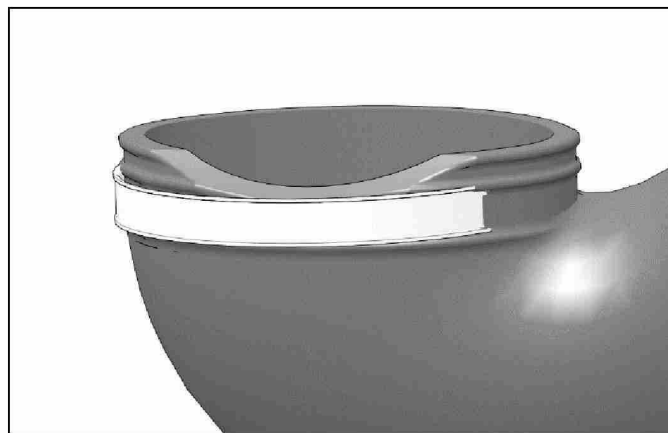
When installing the new clutch outlet duct, route the gear case vent line as shown. Ensure the gear case vent line is not pinched or kinked.

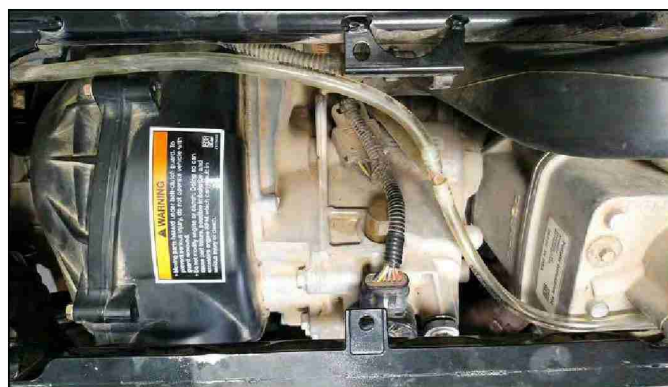
5. Install the Tuflok fastener (6) that retains the clutch outlet duct.

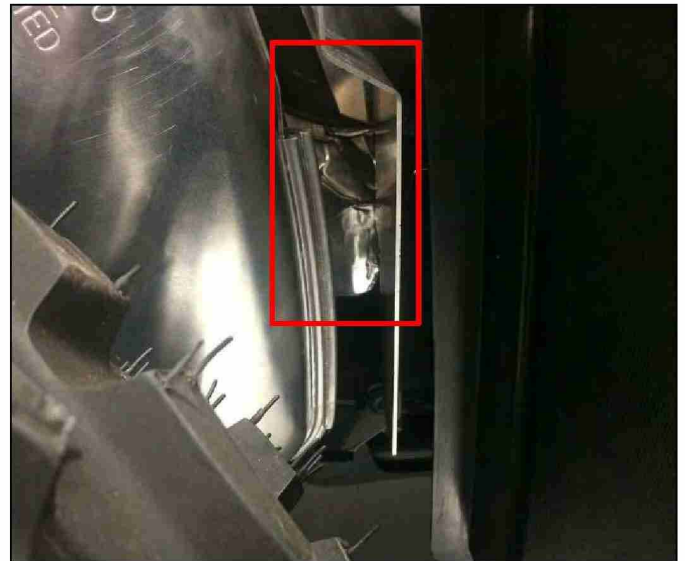
The clutch heat shield should be between the silencer and the clutch cover, as well as the speed sensor. You can view the shield from the right rear wheel well. The heat shield should be the only visible component between the exhaust and the footwell shield.

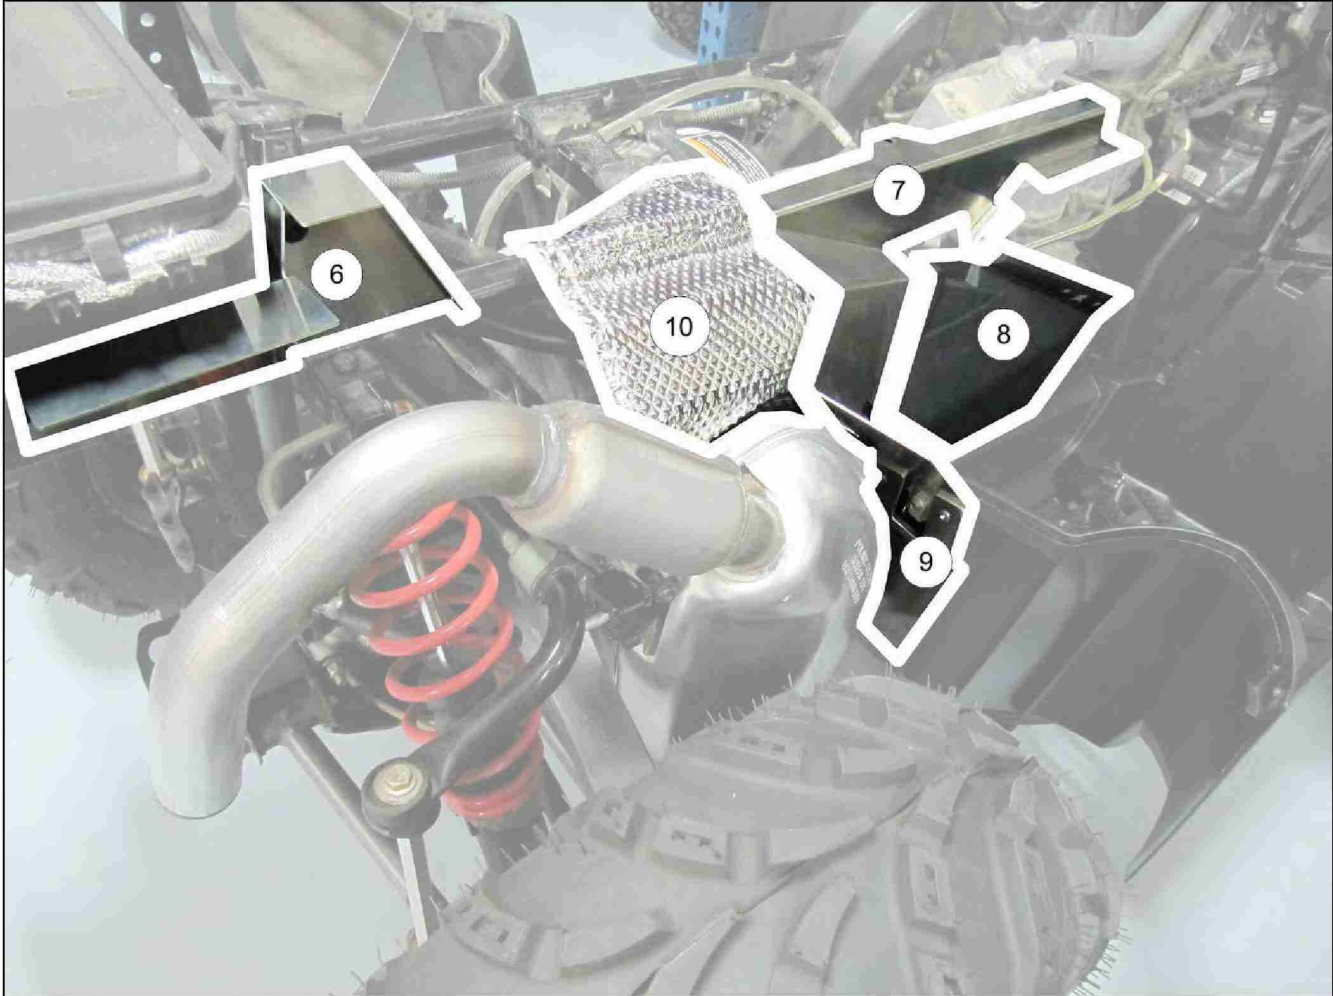
⑥	Rack Support Heat Shield	5264561
⑦	Front Cab Heat Shield	5264561
⑧	Exhaust Manifold Side Panel	2636626
⑨	Footwell Heat Shield	5264564
⑩	Clutch Duct Heat Shield	5264700

10. Take a picture from just above the right rear wheel, pointing toward the center of the machine. Ensure that all heat shields/foils installed are visible. This is one of two pictures required to submit the warranty claim.

A secondary dealer representative must verify that the picture taken aligns with the example and all shields are visible.

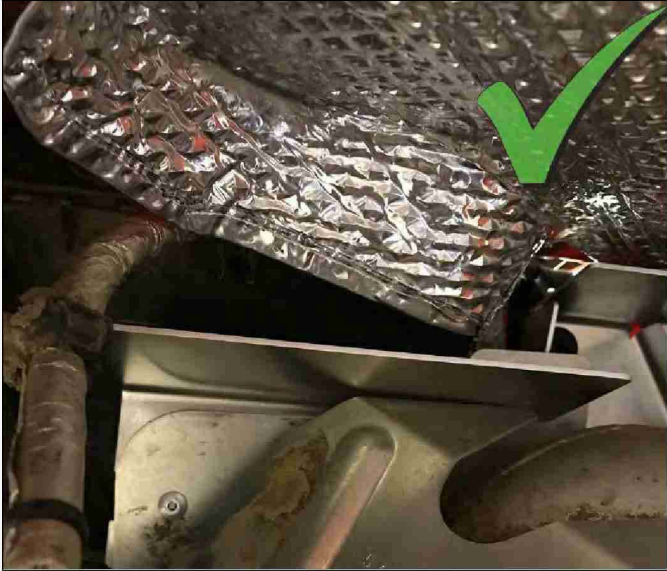
Acceptable – Rear Cab Heat Shield encloses the corner of the storage box and harness

A secondary dealer representative must verify the Rear Cab Heat Shield is bent down and wraps around the corner of the Storage Box and Tail Light Harness. If it interferes when installing the cab, ensure it is bent back down to match the good example below.

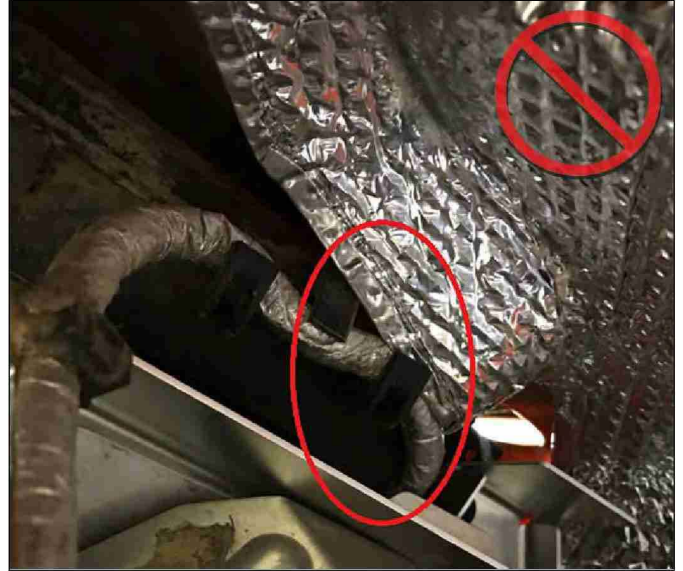
Unacceptable – Rear Cab Heat Shield interferes with the storage box and harness

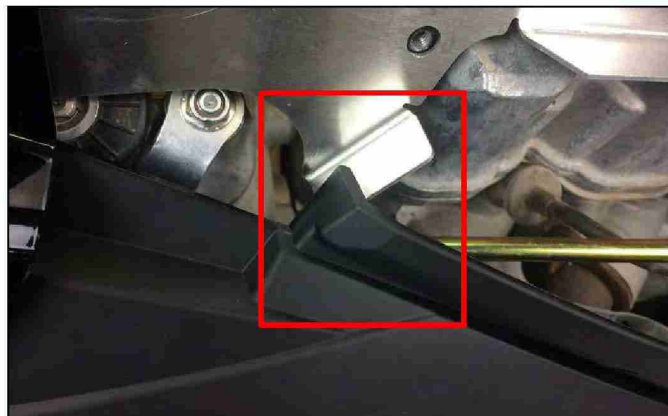
Verify the NEW right-hand exhaust manifold side panel tab is on top of the tab on the front cab heat shield as shown.

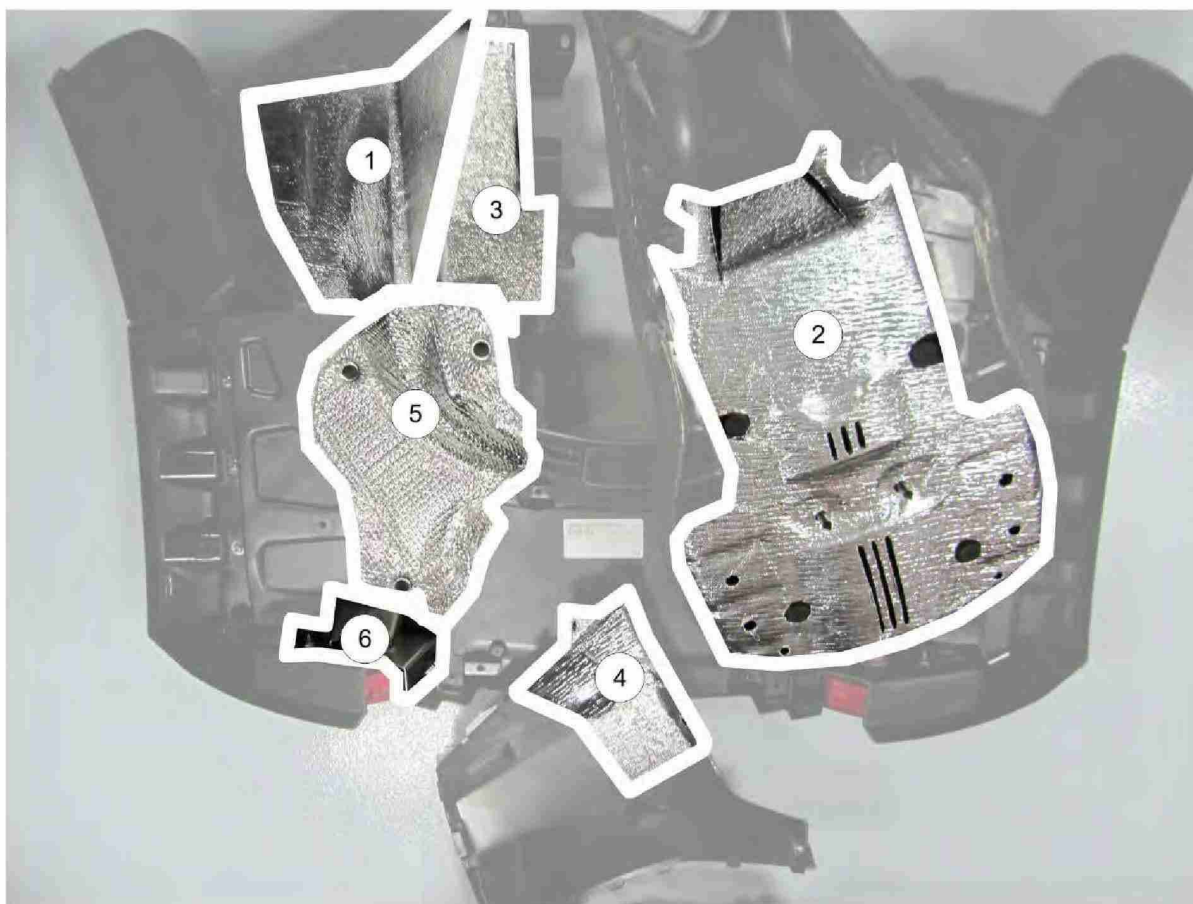
PHOTO 1 - 1000 1-UP - New Thermal Protection Foils

① Existing Rear Cab Foil	DO NOT REMOVE!
② Seat Heat Shield Foil	5814630
③ Rear Cab Heat Shield Foil	5814631
④ Side Panel Heat Shield Foil	5814632
⑤ Rear Cab Heat Shield	5263209
⑥ Tail Light Heat Shield	5264567

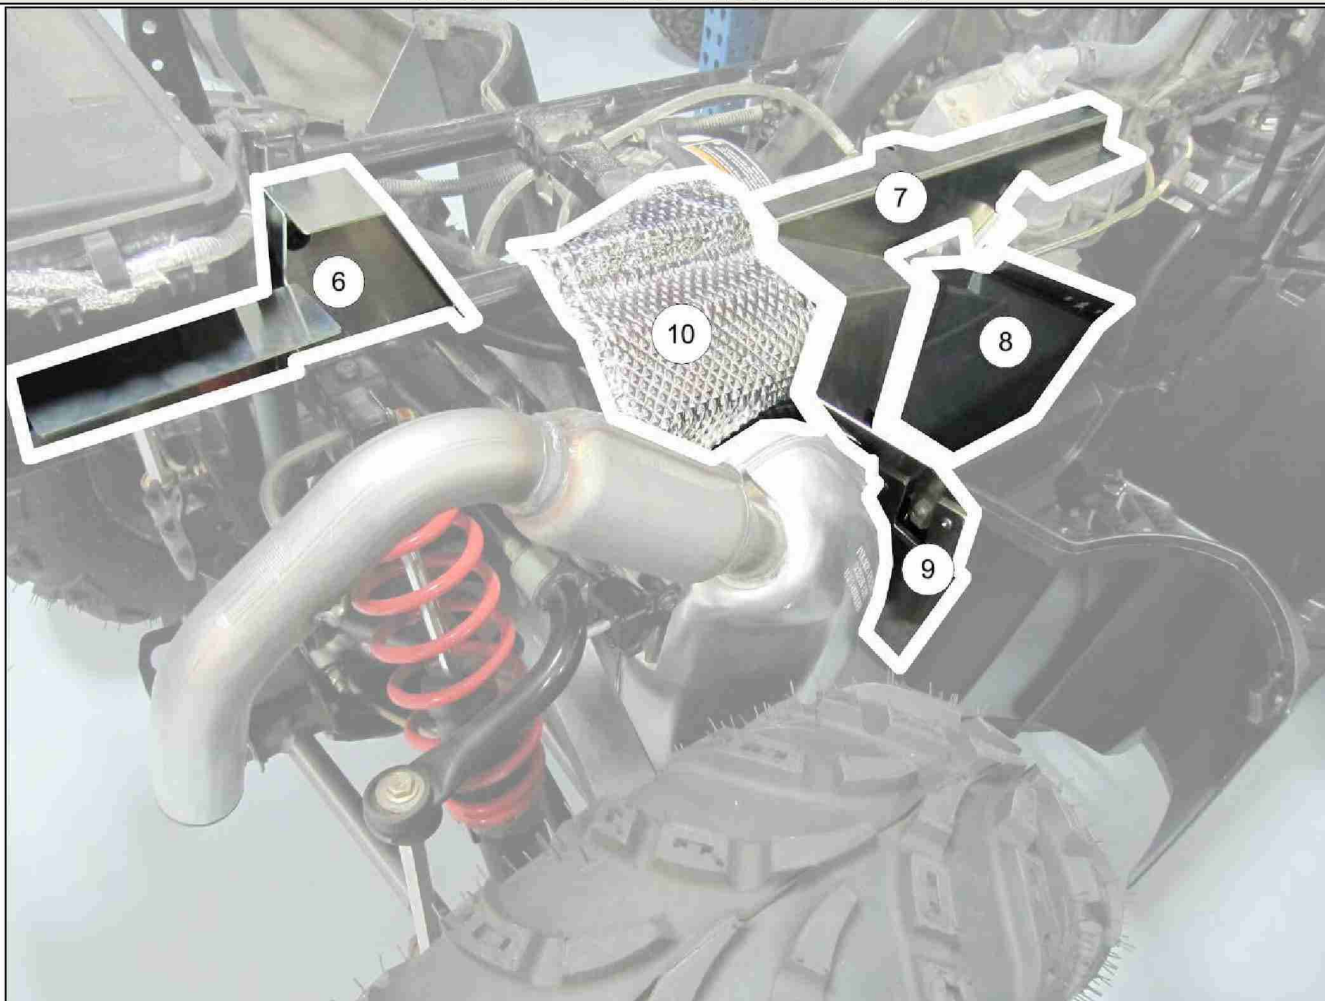
PHOTO 2 - 1000 1-UP - New Heat Shields

⑥ Rack Support Heat Shield	5264561
----------------------------	---------
